Co-seismic deformation of an estuarine terrace, Constitución, Central Chile

In the terrace T_c of Constitución, many fractures and associated deformations of its platform appeared in the street pavements after the earthquake of 02.27.2010. On this basis, this work deals with the co-seismic deformation in this terrace, observed by means of survey of fractures and associated superficial deformations. The principal undulated and irregular surface of the terrace shows no difference between the profiles surveyed before and after the 2010 seism, with exception of those that represent a minor part in the northward sector. In exchange, the flagstones or slabs of pavement show brittle micro-deformations or pop up like array structures associated to micro fractures produced during the seism. There is great dissimilarity of size order between principal irregularities of the terrace surface (undulations) and micro-deformations. The principal irregularities of the terrace T_c indicate that its undulated form is inherited and older than the seism of 02.27.2010. Only a minor part represents a 2010 co-seismic deformation with gentle warping of the inherited undulation during the seism. In exchang

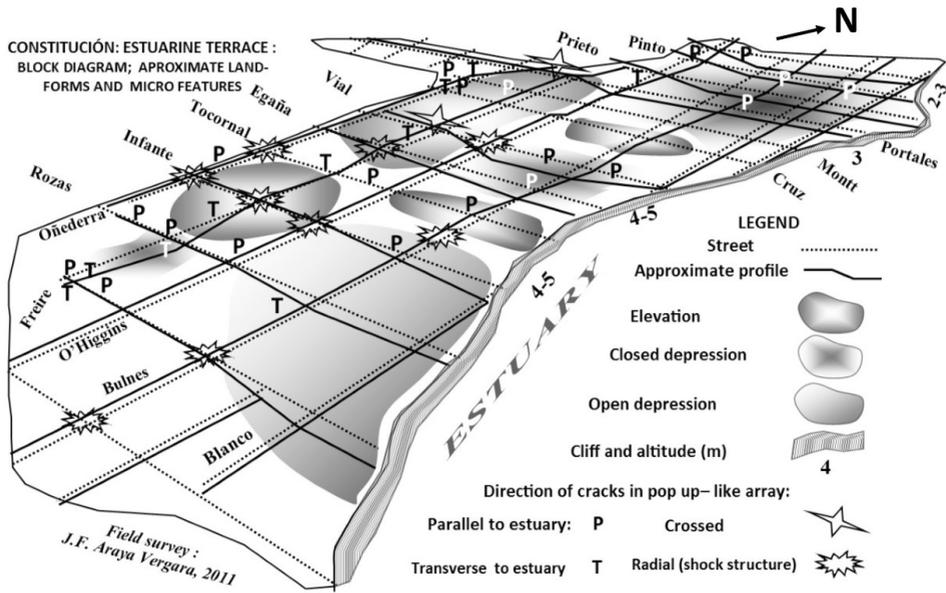
Fig. 2. T_e of Constitución: approximate sight of the principal undulate topography and micro deformations, represented by cracks.

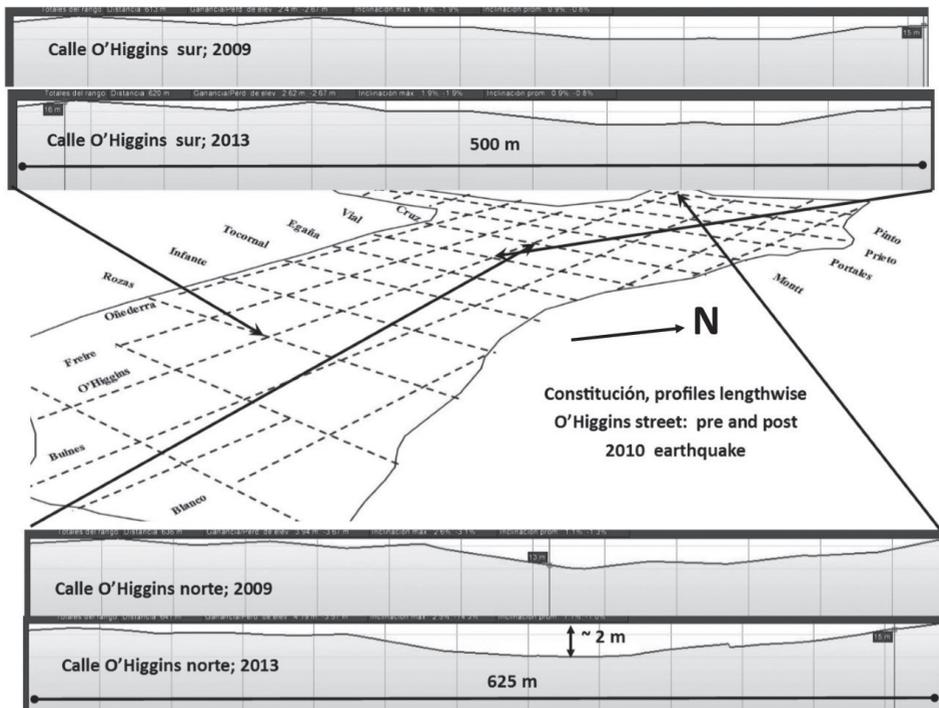
the 2010 seism. However, in the northward sector the distribution of depressions and elevations before and after the seism is incongruent (Fig. 6). This type of change is observed also in the profile of Portales, perpendicular to O'Higgins Street and in the environs of its crossing, what indicate that the deformation affected a specific sector of the northern part of the terrace (Fig. 7). In O'Higgins Street, the zone of change covers ~300 m (between Portales and Pinto streets). The deformation consists in a widening and regularization of the pre-existent bottom in a local depression. The differences of elevation between 2009 and 2013 are commonly decimetrical. The similar deformation observed in the profile of Portales street, near the limit of the deformed zone, indicates a little subsidence trend, but in Prieto Street – northward of Portales – there is no seismic deformation (Fig. 7).

Fig. 6. Profiles of O'Higgins Street, indicating change in the northern part during the 2010 seism.

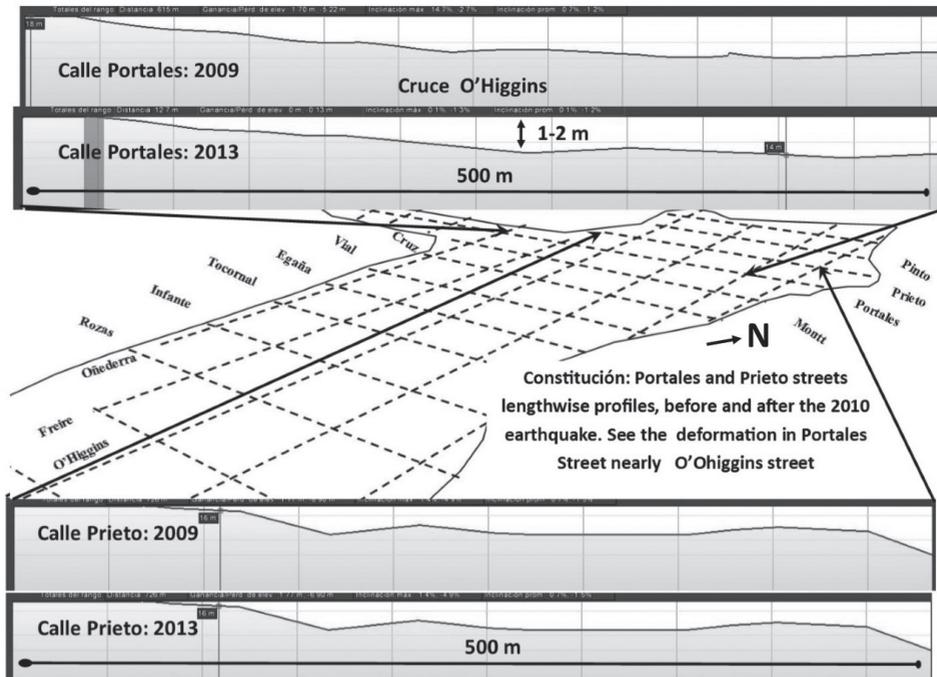
Fig. 7. Profiles of Portales Street, indicating change in the environs of O'Higgins Street during the 2010 seism. Prieto Street as reference.

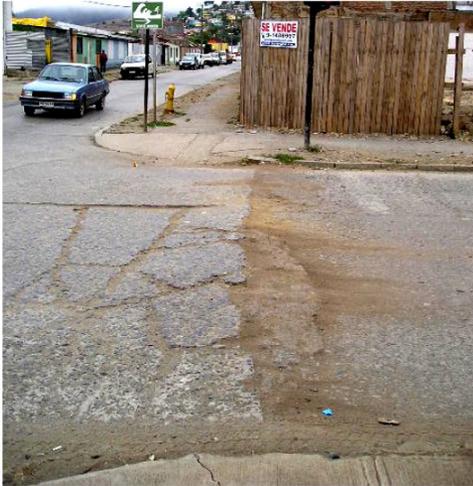
A. Regular transverse fault deformation and irregular fractures in uplifted flagstone

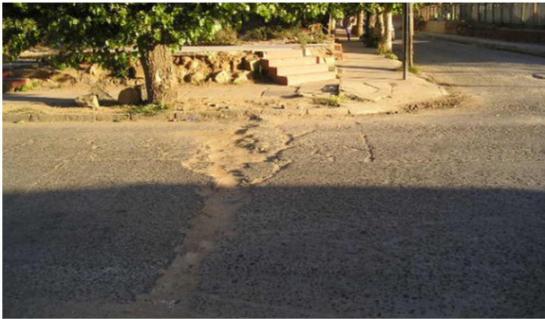
B. Regular transverse fault deformation

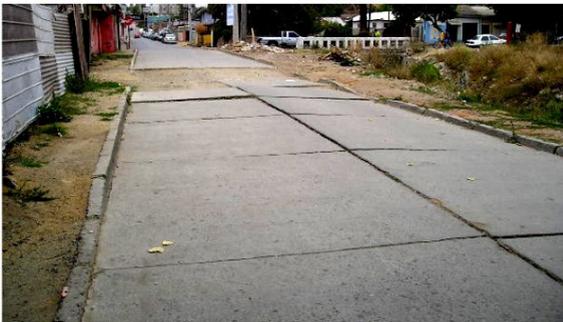
C. Regular pop up-like array deformation by means of transverse fractures

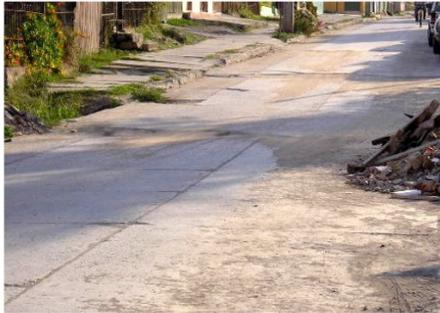
D. Subsident flagstone between two pop up-like array structures

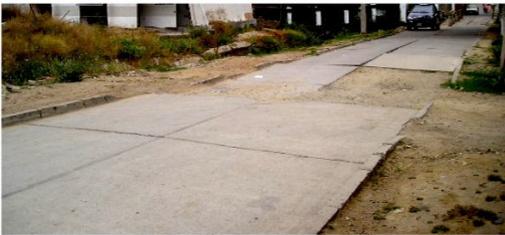
E. Typical pop-up composed by several flagstones

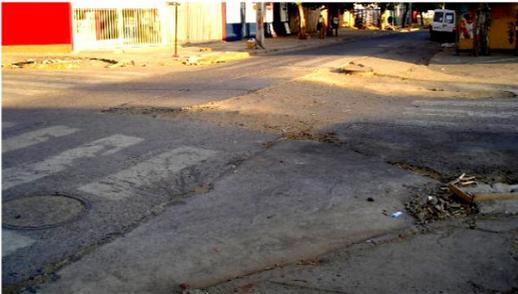
F. Regular crossed pop-up deformation

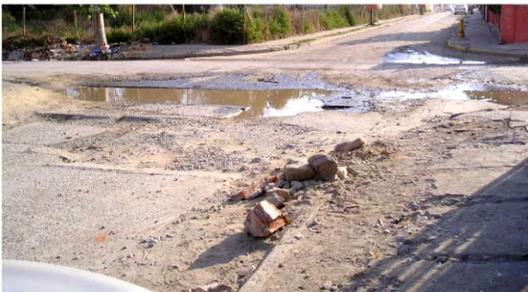
G. Shock structure, including a flagstone with irregular fractures; pop up-like array deformation

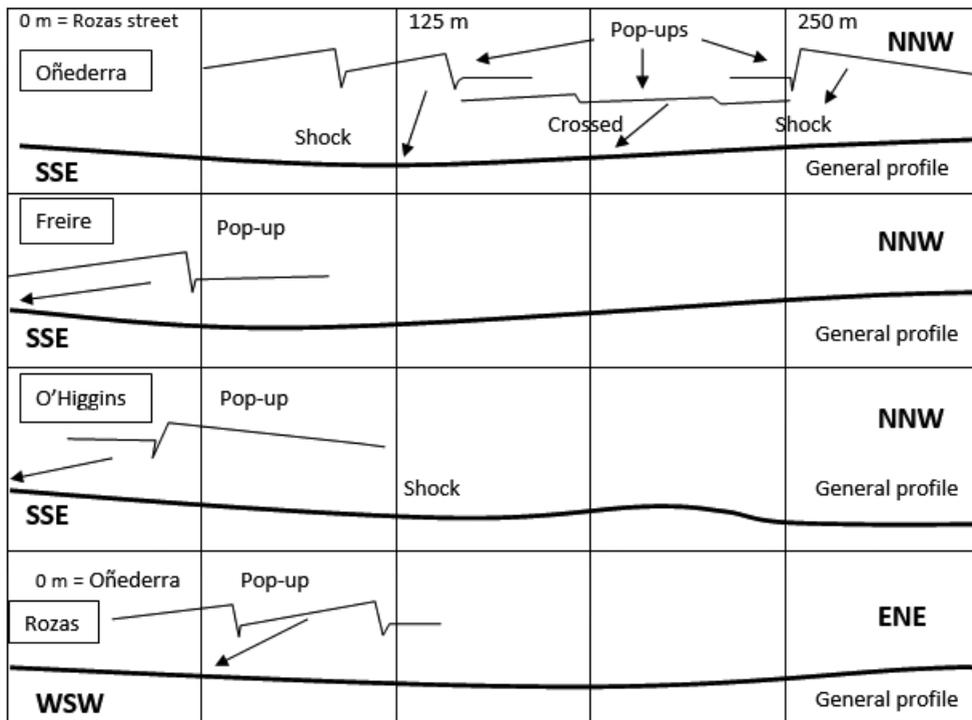
deformations. Altogether, the Figure 2 and 10 indicate that the different types of pop-up and the specific elements of the principal undulation have independent locational patterns. Inside the principal irregularities, deformed flagstones appear indistinctly in summits and depression bottoms (whose declivity angles fluctuate between 0.2 and 1.4°, see Table 1). In exchange, the dip angle of deformed flagstones is generally 2-5° (Table 2).

Fig. 10. Examples of deformed flagstones expressed as pop up-like arrays and their placing in the general form of the respective street pavement profile.
