Co-seismic deformation of an estuarine terrace, Constitución, Central Chile

In the terrace T_c of Constitución, many fractures and associated deformations of its platform appeared in the street pavements after the earthquake of 02.27.2010. On this basis, this work deals with the co-seismic deformation in this terrace, observed by means of survey of fractures and associated superficial deformations. The principal undulated and irregular surface of the terrace shows no difference between the profiles surveyed before and after the 2010 seism, with exception of those that represent a minor part in the northward sector. In exchange, the flagstones or slabs of pavement show brittle micro-deformations or pop up like array structures associated to micro fractures produced during the seism. There is great dissimilarity of size order between principal irregularities of the terrace surface (undulations) and micro-deformations. The principal irregularities of the terrace T_c indicate that its undulated form is inherited and older than the seism of 02.27.2010. Only a minor part represents a 2010 co-seismic deformation with gentle warping of the inherited undulation during the seism. In exchang

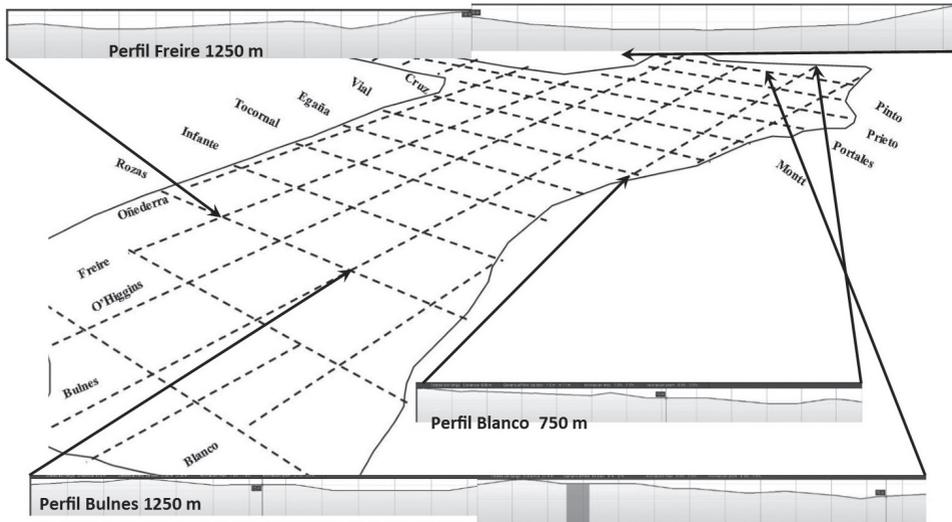
Two order of declivity angle are detached in the terrace surface: a) General and scanty perceptible one, in which the streets with azimuths of ~ 335 show an indifferent

Fig. 3. Profiles of streets (azimuth 335°).

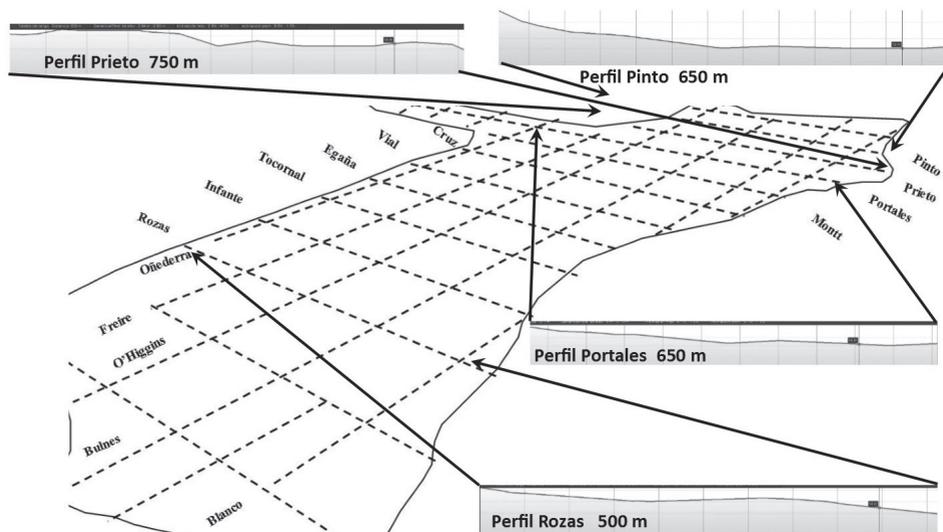
declivity trend (Fig. 3); in exchange those with azimuth $\sim 65^\circ$, point out a landform sloping toward the estuary (Fig. 4). b) Special and perceptible, represented by streets with azimuths of ~ 335 and 65° , which renders possible the description of the principal irregularities (Figs. 3 to 7).

Fig. 4. Profiles of streets (Az 65°).

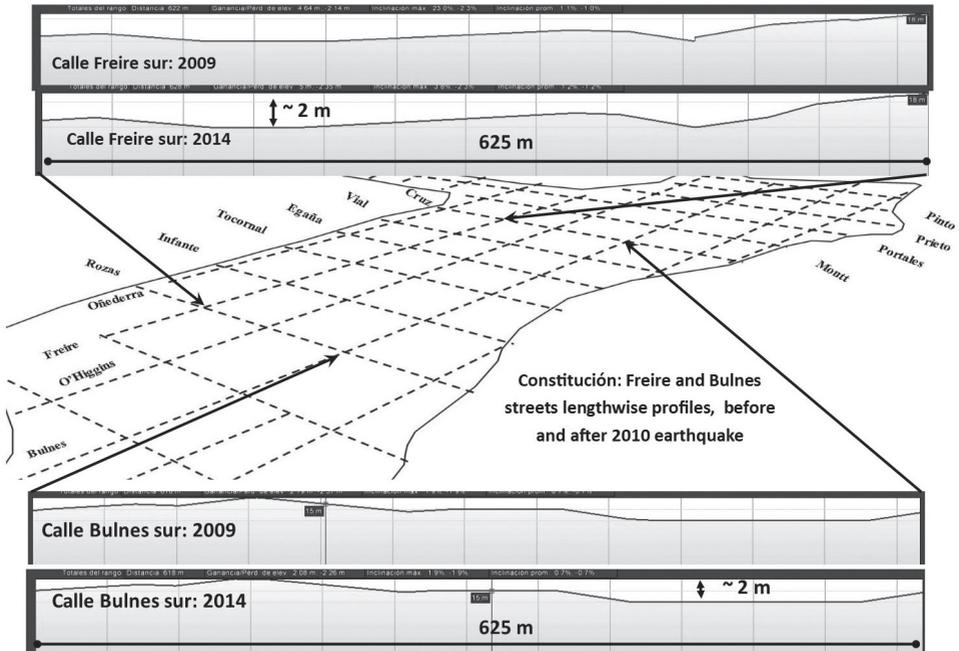
The surveyed profiles of streets indicate topographical differences among them, showing local irregularities of the terrace surface. The differences of elevation among segments of each street are of some decimeters to one or two meters. Generally, the profiles for 2009 and 2013 (before and after the 2010) seism show no morphological difference (Examples in the Fig. 5). Consequently, in the detail, the principal surface of the terrace is gently irregular, but generally unchanged by the 2010 earthquake.

Fig. 5. Examples of street profiles (Az 335°) unchanged by the 2010 seism.

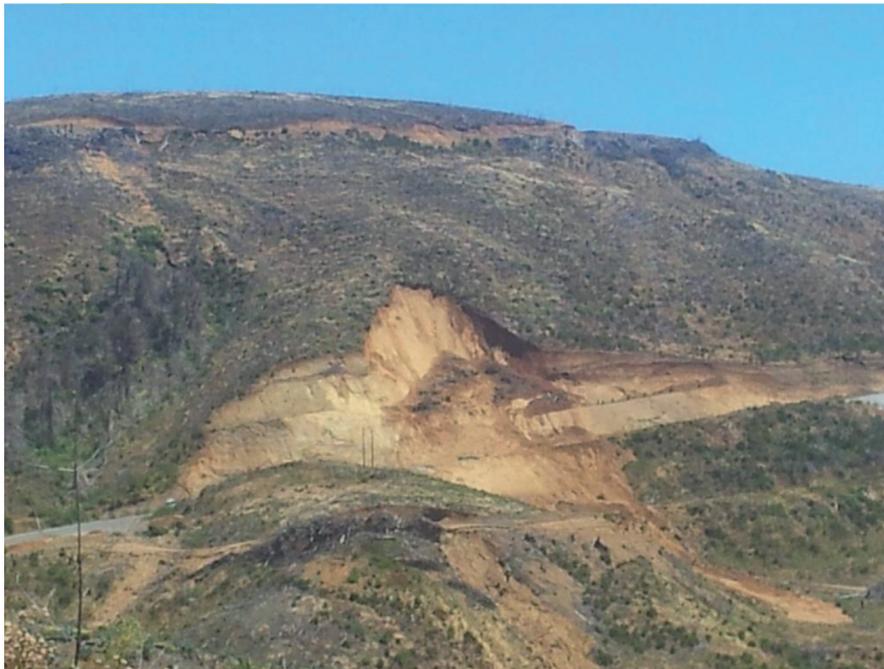
Landslide induced by the 2010 Maule earthquake in the Punta Lavapie area, Arauco Península. Fondecyt 1140317, “Dynamic response and stability of large rock slopes during earthquakes”. Sergio Sepúlveda, Departamento de Geología, sesepulv@ing.uchile.cl, Universidad de Chile.
